State of California The Resources Agency DEPARTMENT OF WATER RESOURCES

SEPTEMBER 2002 OFFICE REPORT

THE INSPECTION OF FLOOD CONTROL PROJECT CHANNELS ON THE SACRAMENTO AND SAN JOAQUIN RIVERS AND THEIR TRIBUTARIES AND THE TRUCKEE RIVER

Prepared By The Flood Operations Branch Flood Project Inspection Section

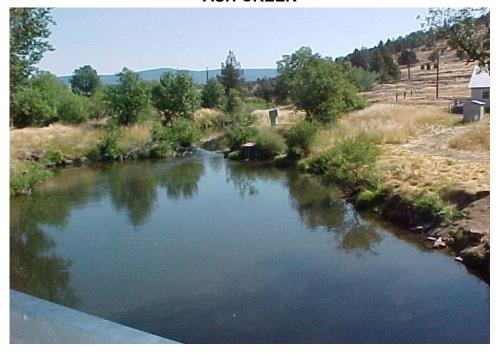
Upstream from Main Street (Highway 299) towards the gauging station.

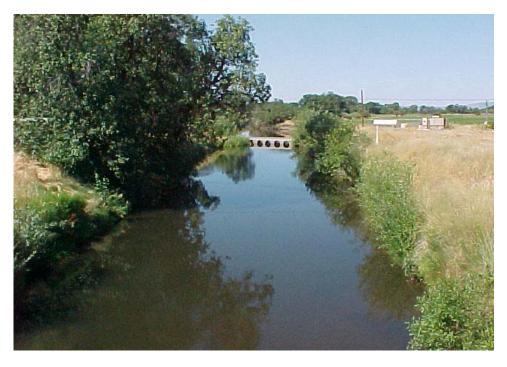
Downstream from Main Street (Hwy. 299) at the Ash St. low water crossing.

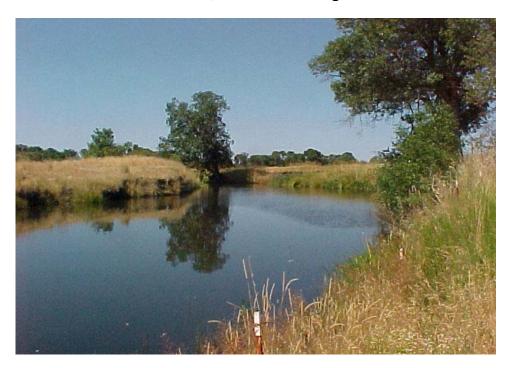
Downstream at a sharp left bend. Moderate erosion on both banks.

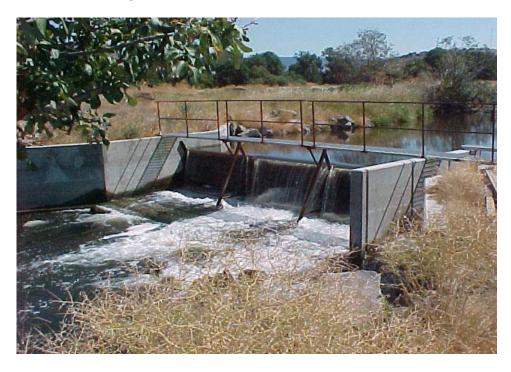
Dam with fish ladder and metal walkway, constructed Oct. 1999 by the Dept. of Fish and Game.

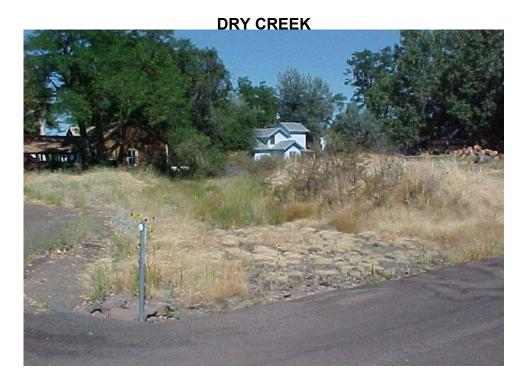
Downstream from Adin Street, light growth in channel.

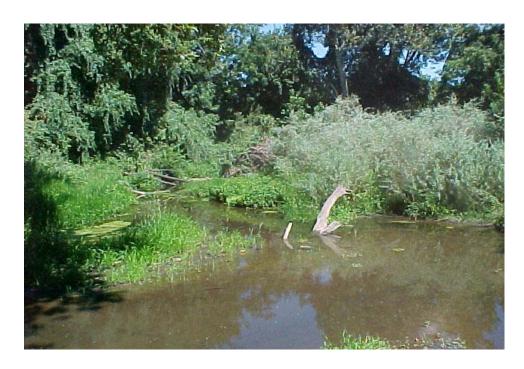
Downstream from the extension of Salt Creek Road, vegetation in the channel.

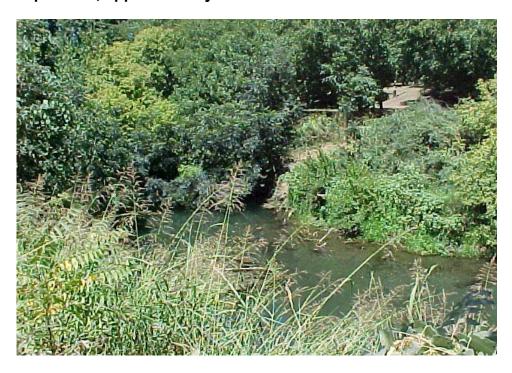
Upstream, approximately 2800 feet from the downstream limit.

Dense vegetation on both banks.

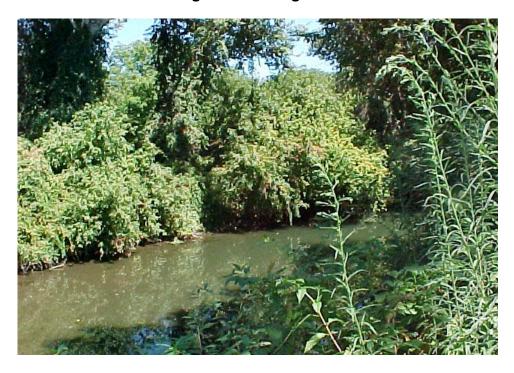
Approximately 700 feet upstream from the confluence of the Sacramento River.

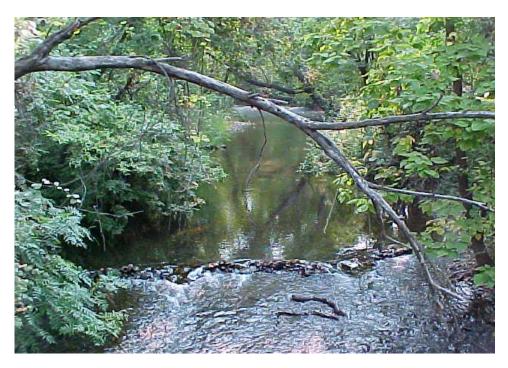
Upstream from bridge near Forest Ave. Heavy growth along both banks.

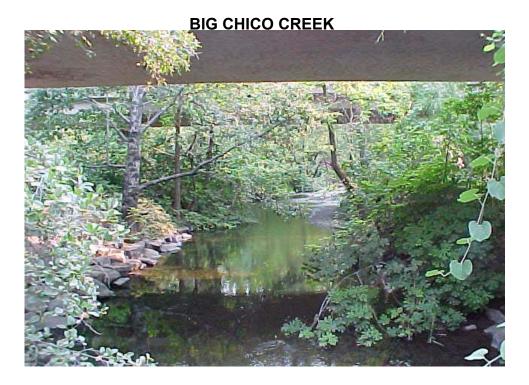
Upstream from U.S. Highway 99. Heavy growth along both banks.

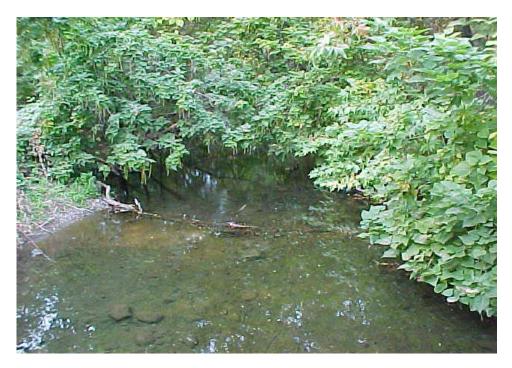
Downstream from U.S. Highway 99. Dense vegetation in channel.

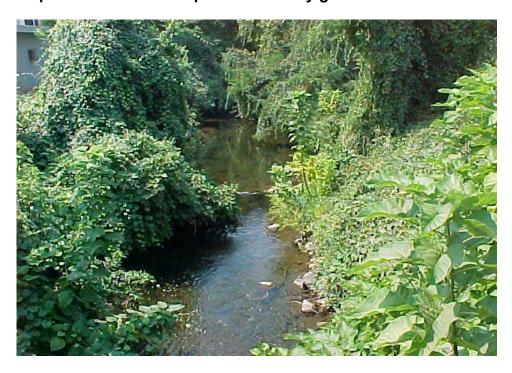
Downstream from Highway 32. Heavy growth on both banks.

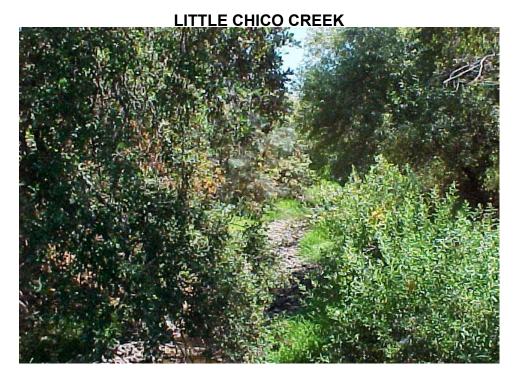
Downstream from the control structure on Little Chico Creek. Moderate growth in the channel.

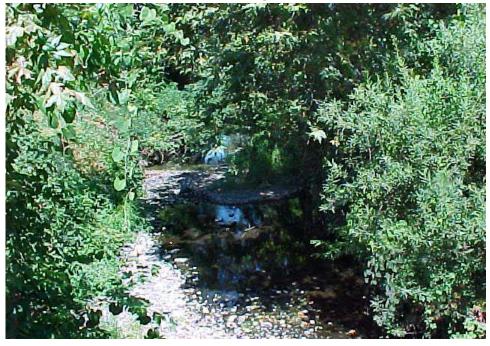
Upstream from Boucher Street. Dense growth on both banks.

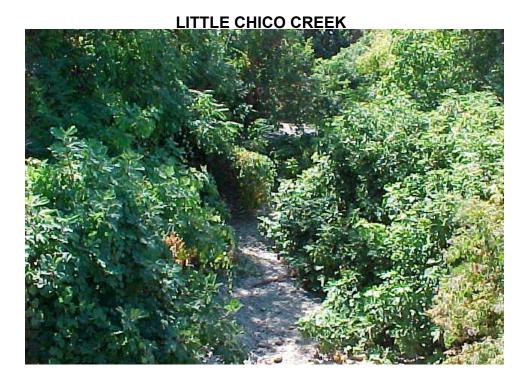
Downstream from Broadway Street. Dense growth on both banks.

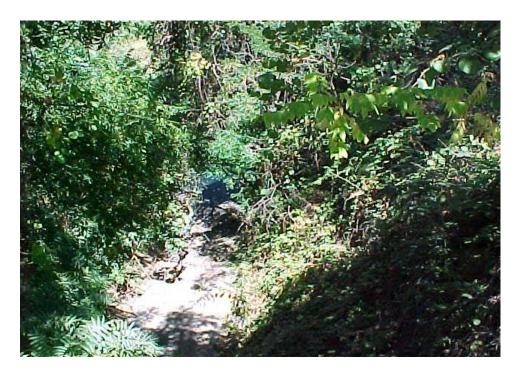
Upstream from Lone Pine Street. Dense growth on both banks.

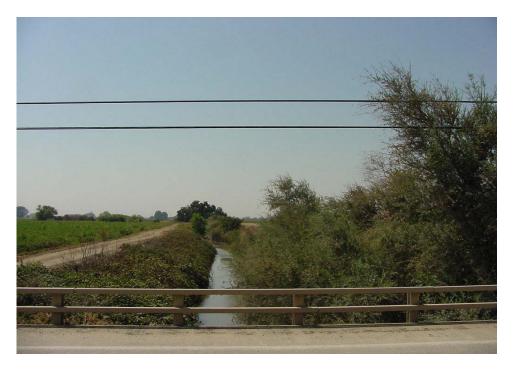
Downstream from Healy Road. Brush and undergrowth needs clearing.

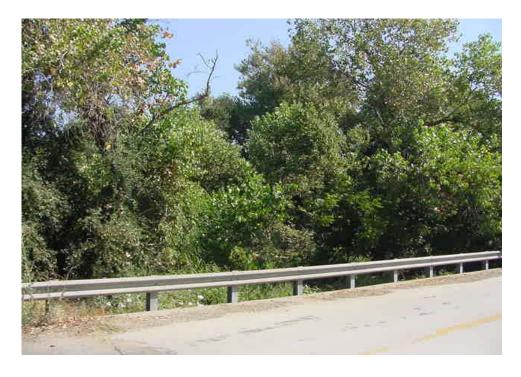
Upstream from Avenue 26. Dense vegetation in channel should be cleared.

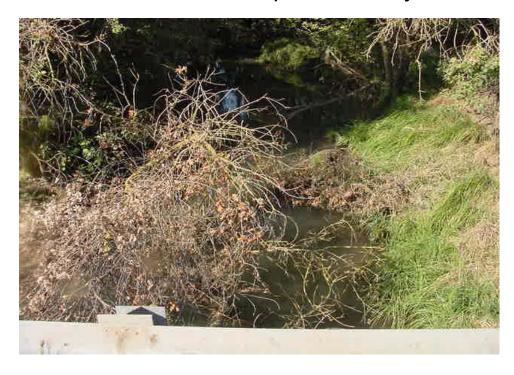
Downstream from Van Allen Road. Dense vegetation in channel.
